CONDITION SURVEY, MARCH AIR FORCE BASE, CALIFORNIA

R. D. Jackson

June 1973

Conducted by U. S. Army Engineer Waterways Experiment Station
Soils and Pavements Laboratory
Vicksburg, Mississippi

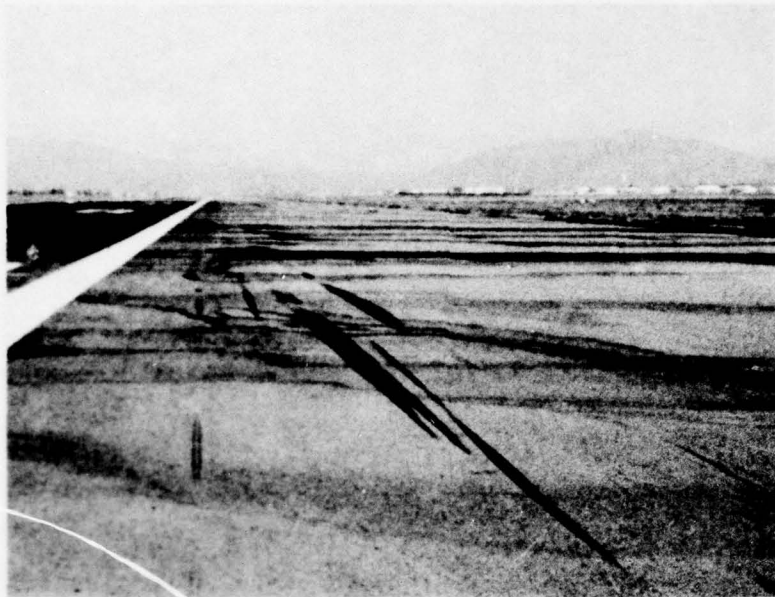
14. The portland cement concrete (PCC) portions of the NW-SE runway (features R1A, R2B, R3C, R4C, R6B, and R7A) were in excellent structural condition, with only a small percentage of the slabs containing major defects. Only four major defects were noted in the entire runway. Feature R5D, the asphaltic concrete (AC) portion, was in very good condition (photos 1 and 2).

Photo 1. AC portion of NW-SE runway near SE end

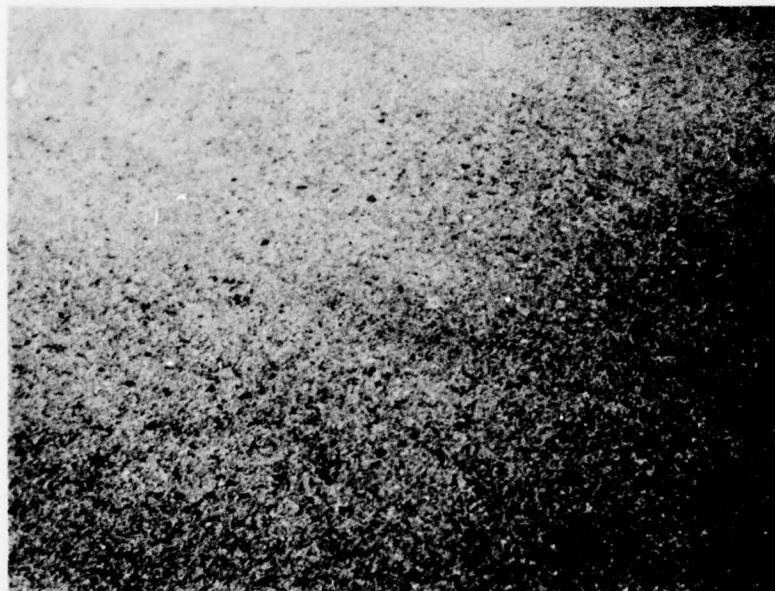
Photo 2. Close-up of AC portion of NW-SE runway near
SE end

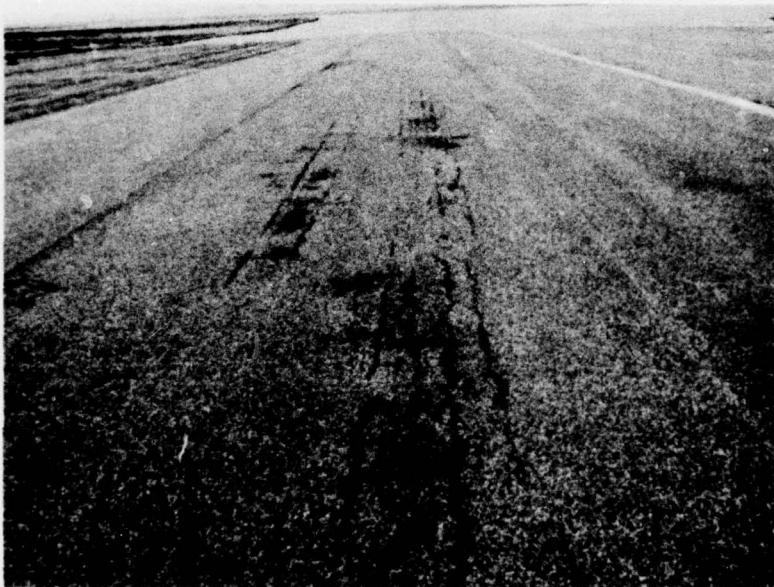
15. Taxiway 1 (features T1A, T2A, T3A, and T4A) was in excellent structural condition, since no major defects were noted. Only seven minor defects were found in the entire taxiway. Features T5A and T6A (taxiway 5) were also in excellent condition. The outer ramp taxiway (features T7A and T8A) was in excellent structural condition based on the percentage of slabs containing no defects. Feature T9A (the outer ramp taxiway extension) was in very good condition. This feature contained 18 major defects, of which 17 were longitudinal cracks in one paving lane. The taxi stripe runs down the edge of this lane, a fact which would seem to indicate that the cracks were load related. Taxiway 5 (features T5A and T6A) contained no major defects and only one minor defect and therefore was rated as being in excellent condition. Taxiways 3 and 4 (features T15C and T16C) were in fair condition (photos 3 and 4).

Photo 4. Typical condition of taxiway 4

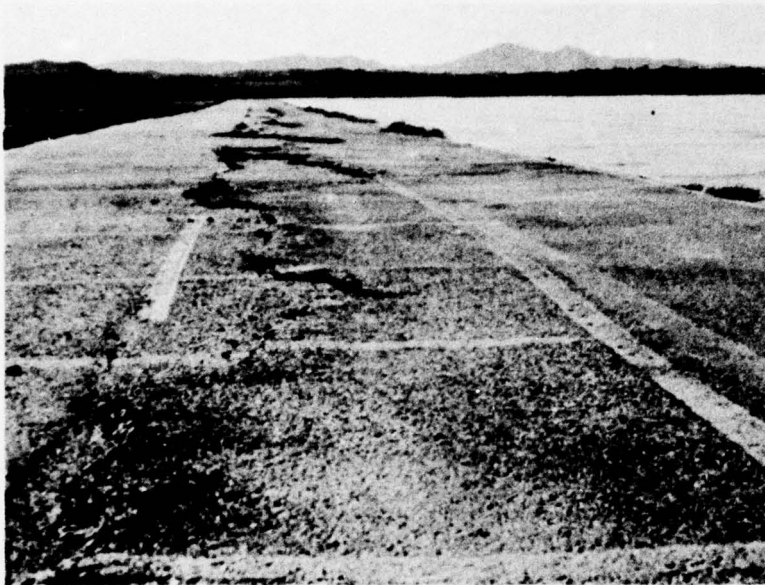
16. The apron areas were in either very good or excellent condition. Major defects were widely spaced, and the minor defects were usually spalls. Considerable shoving of the shoulder pavements along

Photo 5. Showing of shoulder pavement along south end
of parking apron

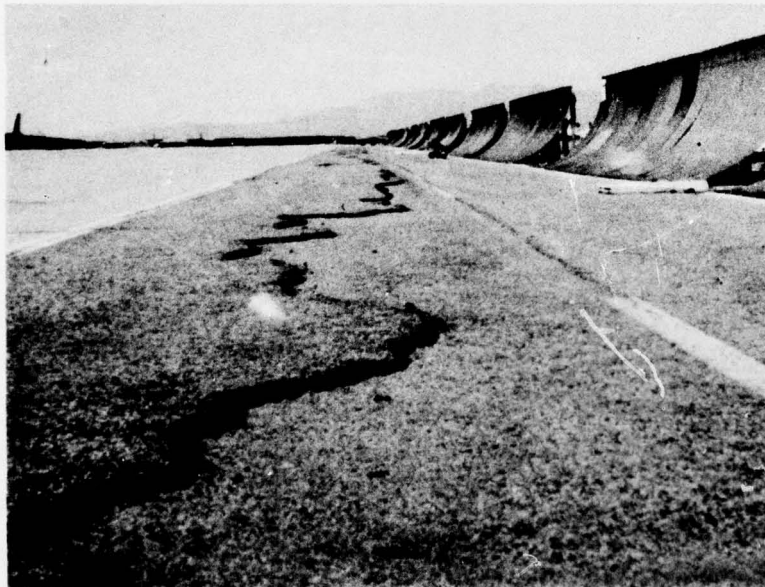
Photo 6. Showing of shoulder pavement along east side
of parking apron near south end

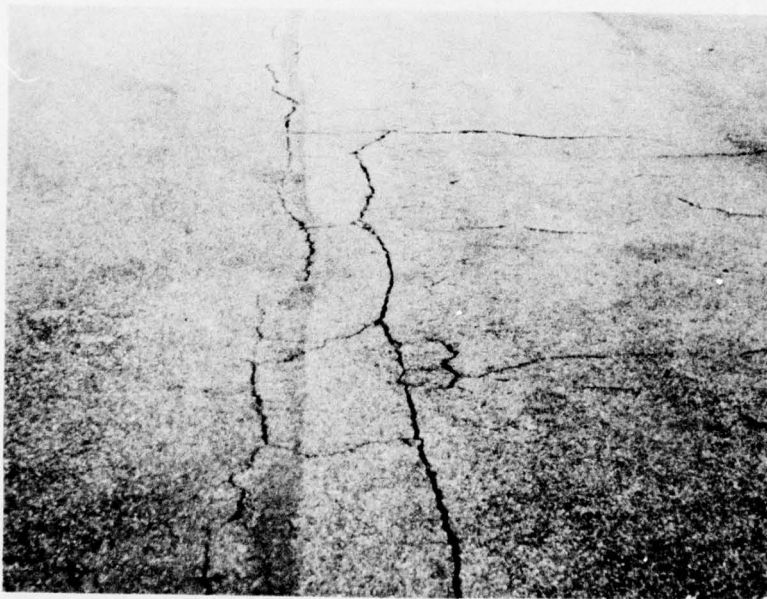
Photo 8. Typical cracks in AC pavement of refueling
portion of parking apron

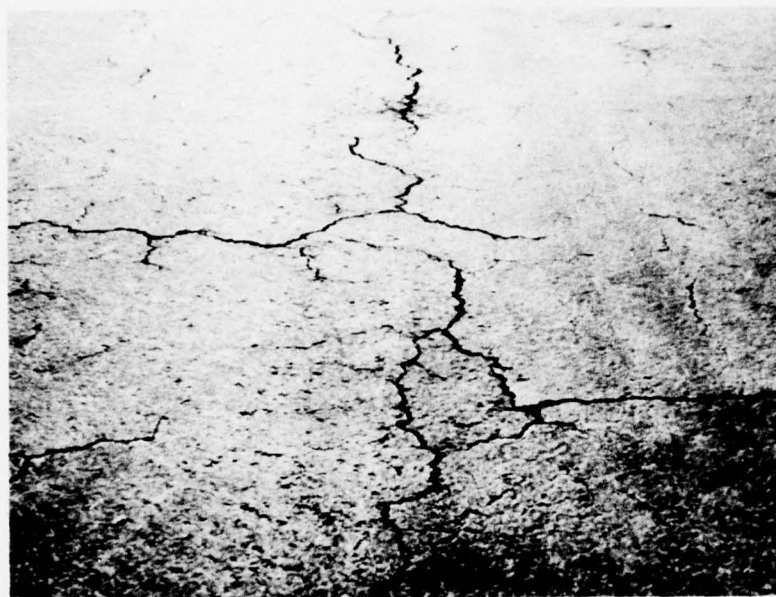
the south and east sides of the south end of the parking apron was noted (photos 5 and 6). Photo 7 shows the upheaval of the shoulder pavement along the east side of the south end of this apron. The shoving and upheaval occurred during 1972 and were apparently caused by expansion of the PCC pavement. Typical cracking of the AC pavement in the refueling area of the apron is shown in photo 8. Photo 9 shows the typically poor condition of the AC pavement on the transient apron.

Photo 9. Typical poor condition of AC of transient apron
